EVALUATION OF THE MONITOR - CTA AUTOMATIC VEHICLE MONITORING SYSTEM

MARCH 1974 FINAL REPORT

URBAN MASS TRANSPORTATION ADMINISTRATION

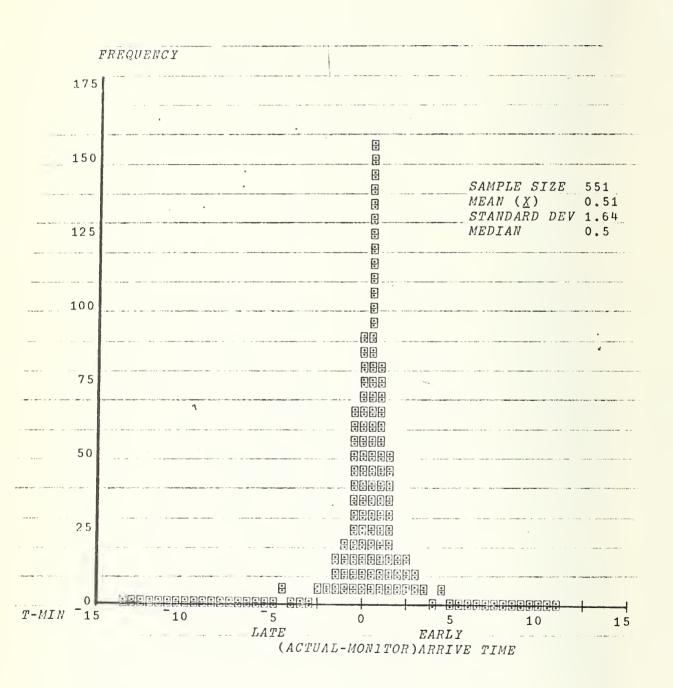
Figure 5.1 System Accuracy Test (Histogram)

The results of the test are presented in the Figure 5-1 histogram. The precise cause of the +30 second mean system accuracy error cannot be pinpointed. The standard deviation of 1.63 minutes indicates that at least 95% (2 σ) of all test buses exhibited system accuracy within +3.8 to -2.7 minutes. Reviewing Table 5-1, only two known sources of error, electronic failure of elapse time clock and software, could contribute to the value of σ .

The realistic system's mean error is approximately equal to zero, with a range of +18 seconds. Comparing these results with the system accuracy error observed during the test, the existing accuracy error was found to be too large. In order to reduce the present accuracy error, it appears that modifications of the existing software must be made and the problems associated with failures of the elapse time clock must be corrected.

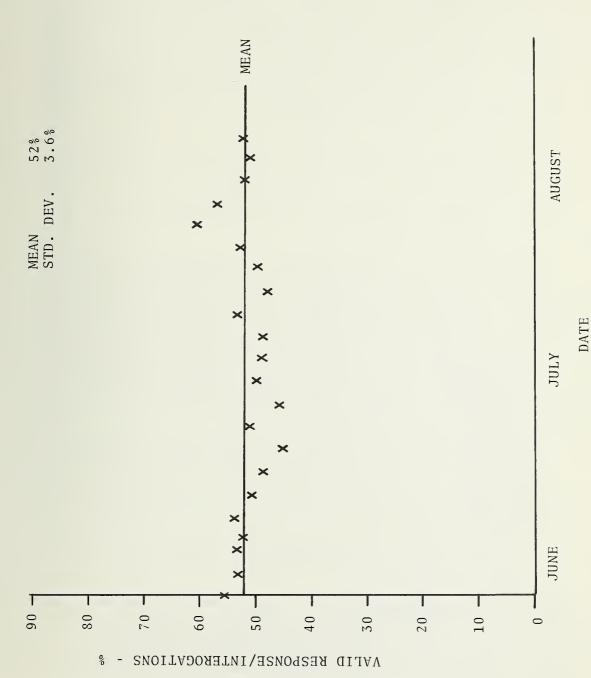
Figure 6-3 Daily Valid Response Rate

A sharp decrease in the daily ratio of valid response rates would indicate some type of communication equipment failure. The data plotted on Figure 6-3 indicates that no sharp decrease in the valid response rate occurred in July. Also, a recent test conducted by the CTA prime system contractor indicated that over 99% of the in-

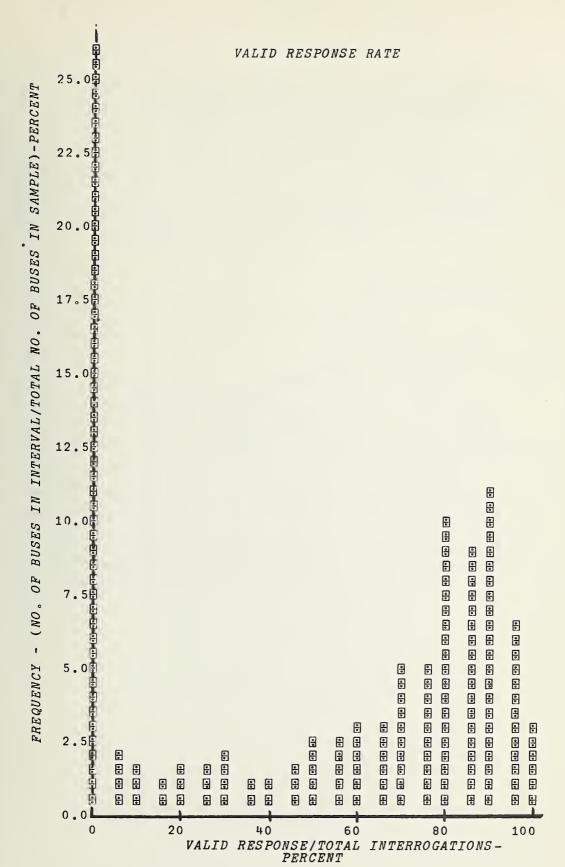
Figure 6-4 Valid Response Rate

To determine what caused the 42% no reply rate, a sample of 724 bus runs were drawn from the July interrogation summaries. A histogram of the valid response rates for this sample is presented in Figure 6-4. Notice that the statistical "mode" (26%) occurs at the zero valid response rate. On the average, 26% of the "owl" monitor bus population is inoperative (zero valid response rate). Information supplied by the CTA (see Appendix E) indicated that of this 26% inoperative bus population that

- 1) approximately 2% of the 26% was attributable to the improper entry of the bus run number (a human error);
- 2) approximately 16% was due to bus receiver-transmitter
 failure;
- 3) the remaining 9% was attributed to either (1) or (2) above.

From Figure 6-4 histogram, one might expect that the bus receiver-transmitter failure could account for the other low response rates (5-30%), exhibited by 9% of the bus population; however, the interrogation summaries do not provide the needed detail to validate this hypothesis.

In order to significantly upgrade the existing system, the deficiencies associated with the bus-receiver-transmitter units must be corrected. This step will not only have the obvious benefit of increasing the system valid response rate but also significantly decrease the average burst length of no replies. To determine the minimum system valid response rate that is required to

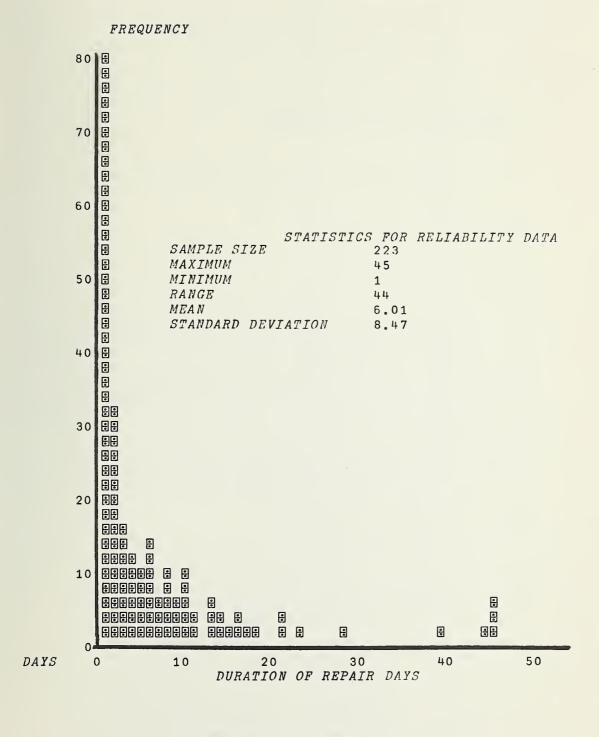
Figure 7-1 Bus Time In Shop

- 1) Failure record statistics (Table 7-1) This table presents a summary of the results of the analysis.
- 2) Number of mobile equipment units in shop daily (Figure 7-1) during the 45 day test period an average of 35.5 mobile units were in the shop each day. (Out of a total of 500 units.)
- 3) Length of time that equipment remained in shop (Figure 7-2) This histogram shows that on the average a defective mobile unit remained in the shop for six days; however, six units were in the shop for at least 45 days.
- 4) Reliability Data
 - a. by bus and fuel type (Table 7-2) correlation between mobile unit failure and bus type and fuel type
 - b. by garage (Table 7-3) correlation between mobile unit failure and bus garage

The data clearly indicates that a high failure rate of the mobile equipment is occurring. The data presented in Table 7-1 shows that on the average an individual mobile unit fails every 80 days. This could be indicative of a design problem associated with the unit. Preliminary analysis indicates that a time counter in the mobile unit may be a large contributor to the failure rate; however, further analysis is required. Since no reliability specifications are available for this particular equipment, a ballpark estimate of the mean time between failure (MTBF) was made. It was determined that generally two-way radios, similar to those used in the mobile unit, have an MTBF of approximately two years. Even though the mobile unit used in the CTA system contains more components than a two-way radio, a ballpark estimate for the mobile unit's MTBF is one year. Repeating, this is an order of magnitude estimate only.

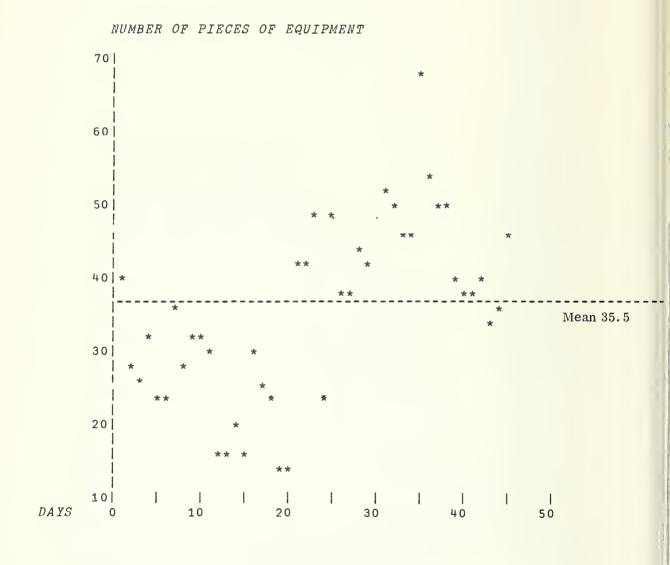
Figure 7-2 Equipment In Shop By Day

1. Average time to get defective street into shop	unit off	4.8 days
	2. Average shop time to repair a unit (Figure 7-2)	defective	6.0 days
